# PLUMBING Express

## What is Polybutylene?

### Polybutylene Pipes and Insert Fittings

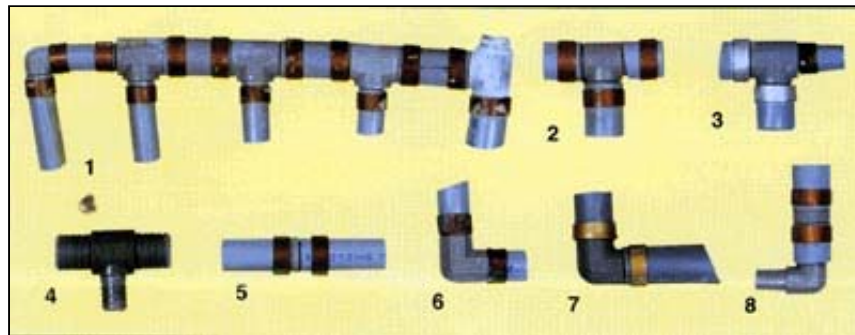
These are typically gray or white in color with a dull finish. Most are shown with pipe attached. Figure (4) is a new fitting.

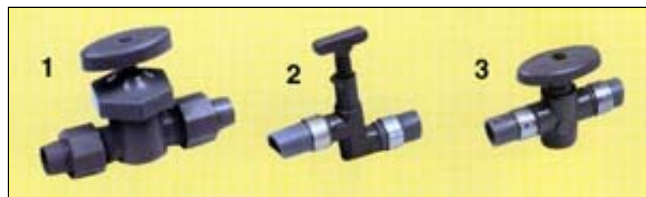
Valves-  
Typically  
found under  
sinks and  
toilets.

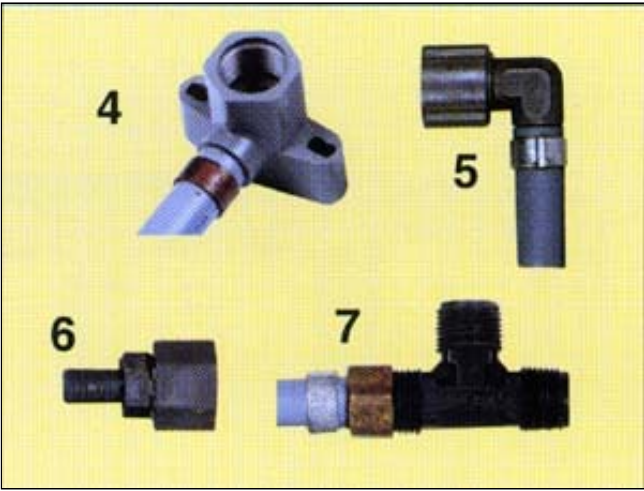
Adapters-

Typically used to connect polybutylene pipe to fixtures.

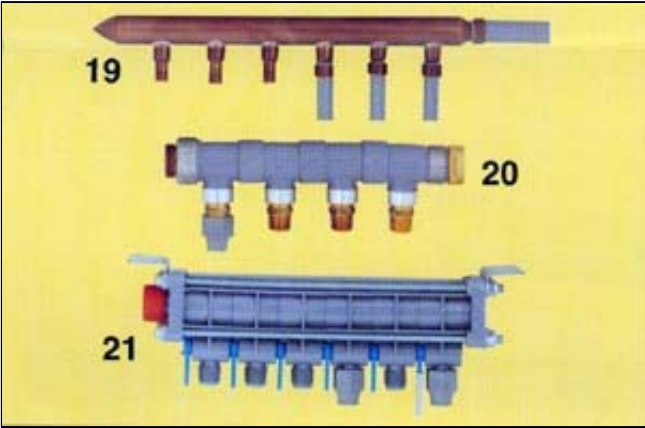
Other fittings.

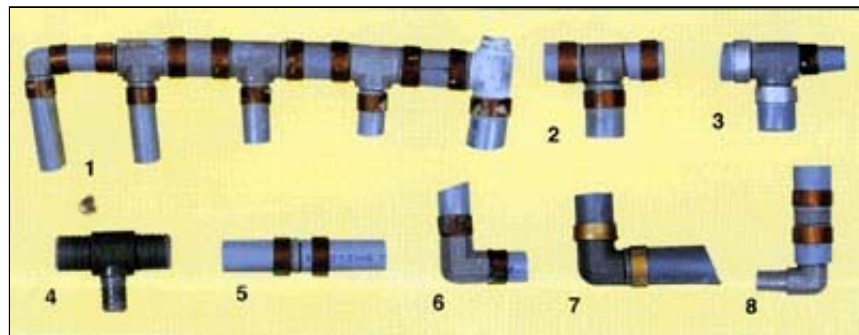
These are typically gray or white in color with a dull finish. Most are shown with pipe attached. Figure (4) is a new fitting.

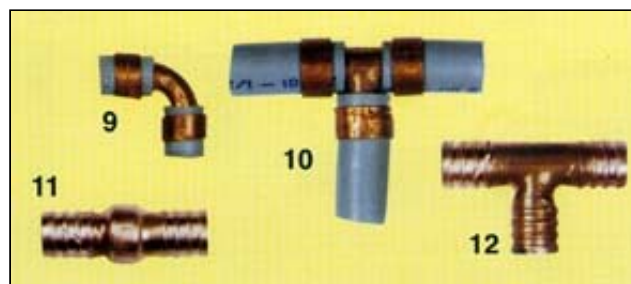
Metal Insert Fittings-  
These are typically made of copper or brass. New fittings are shown in (11, 12).

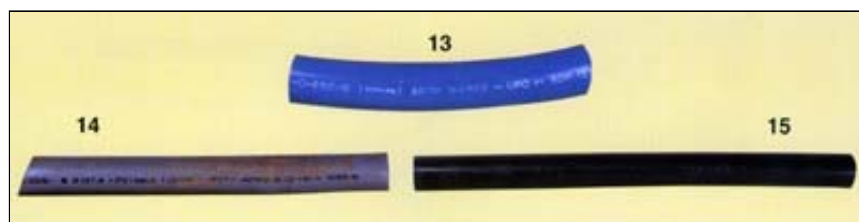
Polybutylene Pipe- Yard Service Line is typically blue (13), gray (14), or black (15). Inside Pipe is typically gray (14) or Black (15).
